Overhaul boosts elevator safety

A Muller Beltex overhaul has improved the safety of a 50-metre elevator in the Port of Brest in France. The elevator, owned by Bunge, has been given new drive and return pulleys, and has undergone a major improvement to its safety systems.

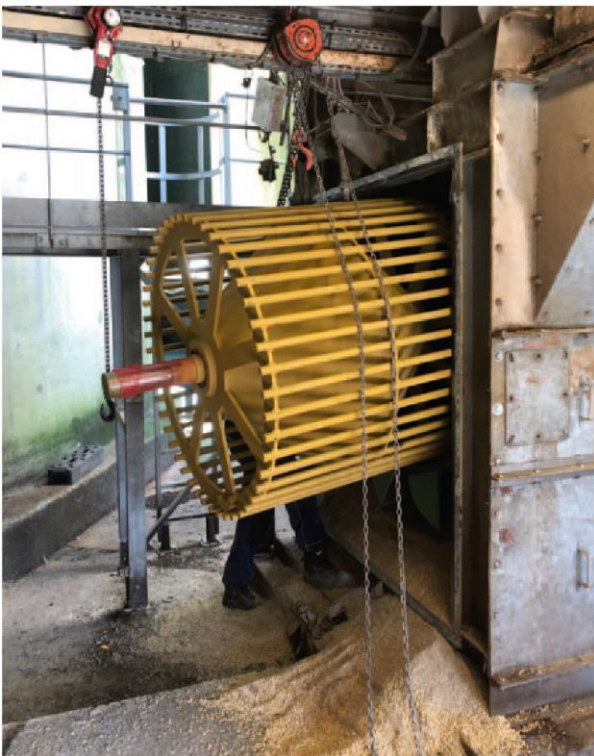
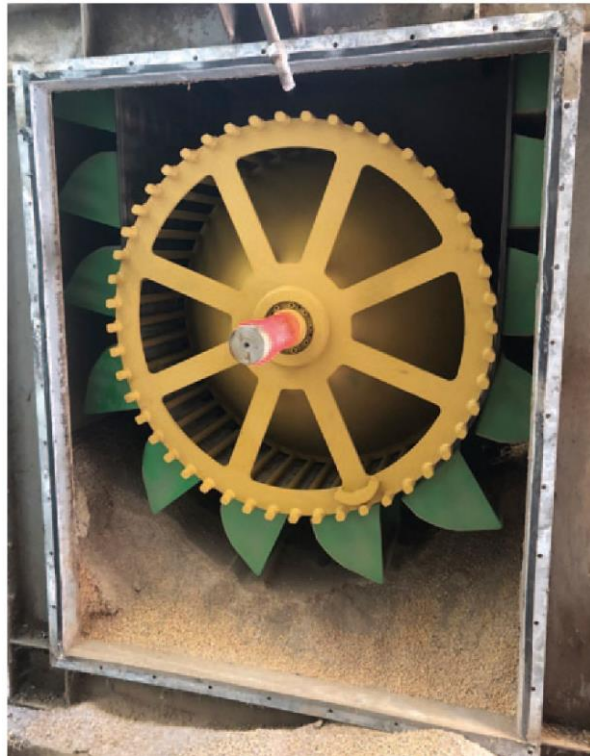
It quickly became apparent in the inspection that both the drive and return (lower) pulleys needed to be renewed. Both were worn from the heavy loads and the product's abrasive properties. Their crowns had become flattened, increasing the risk of the elevator belt running out of alignment. The inspection also highlighted mounting problems with the misalignment monitoring system.

Fig. 3a and 3b The cage pulley is hoisted into the installation

A decision was taken to replace the existing return pulley with a cage pulley, fitted with a discharge cone. This cone ensures that any product caught between the belt and the pulley flows back easily into the product stream through the sides of the cage pulley. Several obstacles at the foot of the elevator had to be cleared before the worn pulley could be removed. The cage pulley was fitted with new bearings and was remounted in the installation using tackles.

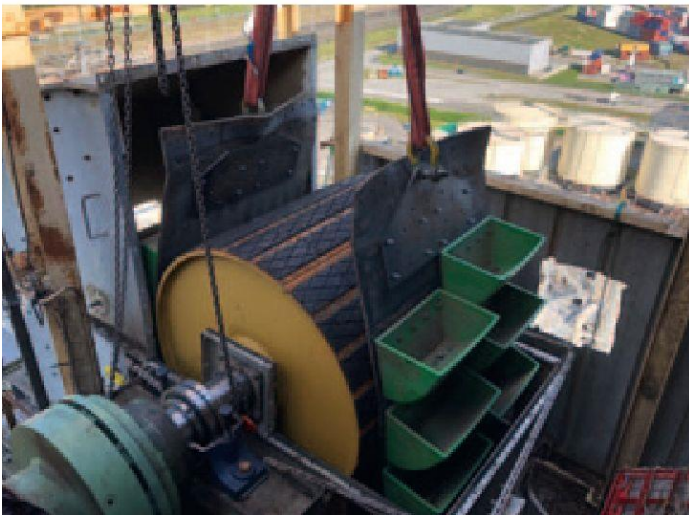
Fig. 4 The drive pulley is mounted in the head of the elevator

The new 2.5 tonne drive pulley has a replaceable lagging (slide lag). The strips covered with NBR rubber are highly resistant to oils and grease, and ensure optimal friction between the drive pulley and the Polysur elevator belt. The elevator head's casing had to be disassembled for hoisting to replace the drive pulley. Steps were also taken to ensure that the installation had been set to safe mode. The belt fastener of the 9-tonne elevator belt was turned to the top of the drive pulley, and the belt was then secured with specially-manufactured belt clamps. Next the fastener was disassembled and the belt was folded open, enabling the drive pulley to be removed. The hoisting operations were completed successfully with a 220 tonne telescopic crane, despite strong winds. The new drive pulley, with its new bearings, was mounted safely and smoothly.
